Pedestrian Road Safety Audit

University Boulevard (MD 193) and Colesville Road (US 29)

Montgomery County, Maryland

July 2011

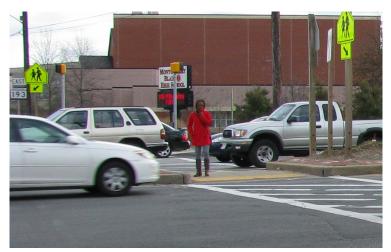
Figure 9: Colesville Road Median Refuge

Raised Median: A raised median, approximately 8 feet wide, is provided along Colesville Road through the study area. Although the county's pedestrian signals are timed to allow pedestrians to cross the entire the width of the roadway, this median provides a refuge for pedestrians that may disregard the pedestrian signal and begin crossing at a time other than during the WALK phase of the pedestrian signal. At the Colesville Road intersections with both University Boulevard eastbound and westbound, the ends of the median are capped by diverter islands that provide a physical separation between vehicles in the intersections and pedestrians in the marked crosswalks.

Pedestrian in median refuge on Colesville Road
